ON PREDICTIVE CONTROL USING THE VIBRATION DETECTION METHOD ON CONDESATION DAMAGE TO THE MULTISTAGE 2 ROTORS CENTRIFUGAL PUMP MACHINE WITH FRONTAL SEALING

EXPERIMENTAL RESULTS ON PREDICTIVE CONTROL METHOD USING FAULT DETECTION USING VIBRATION TO MULTISTAGE CENTRIFUGAL PUMPS WITH TWO ROTORS FP19

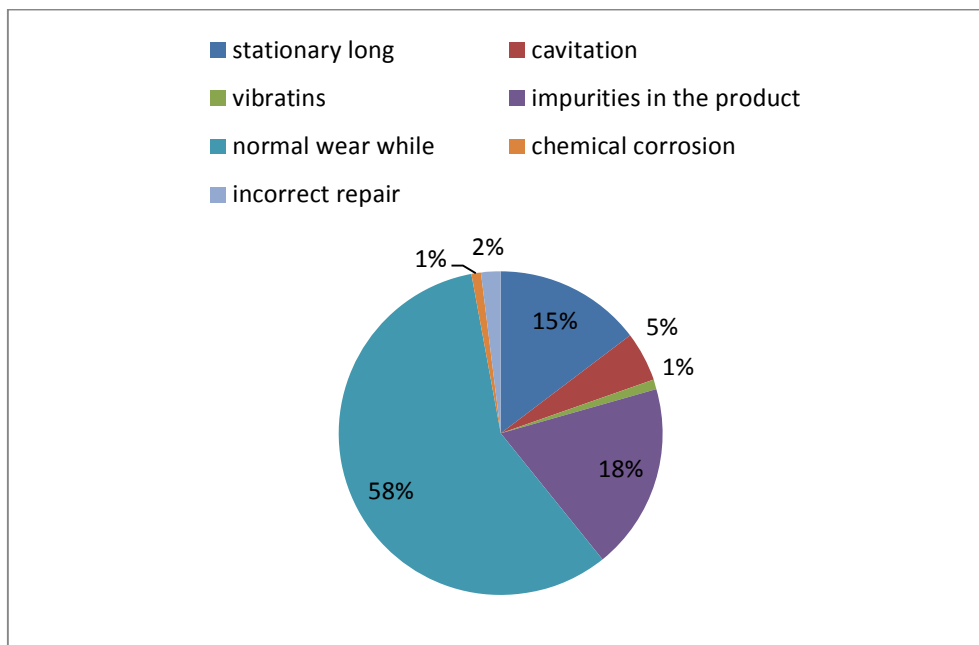
Figure 2. Causes leading to damage the front seal

It can be easily seen that the first four possible causes (beyond normal wear) that led to the front seal damage are impurities in the product - 18%, stationary long - 15%, cavitation - 1%, vibrations - 1%, figure 2

The first three causes accounted for 35% of the percentage values are technological problems that lead to the need for discussions with the departments involved, to increase the reliability of the technical process. The chart shows that the percentage of normal wear time is 58%, which means that the problems raised responsible company should be respected.

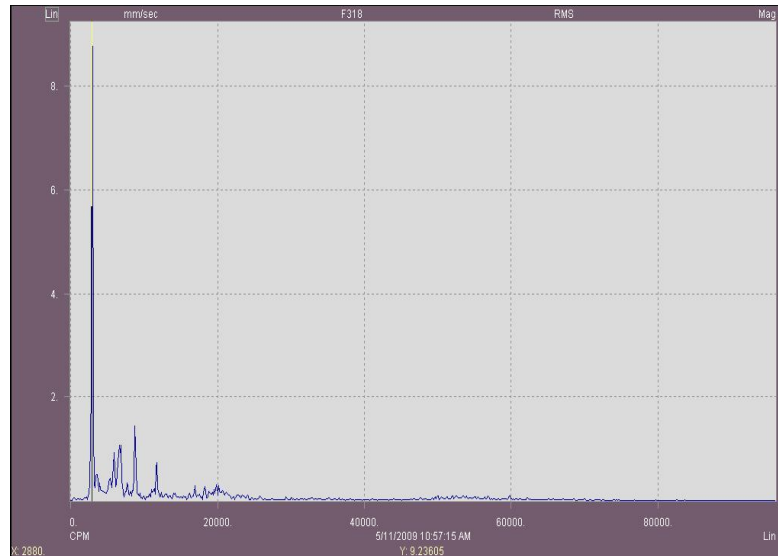
Figure 5. Spectral analysis before the fault rectified

Spectral analysis shows a misalignment of the whole rotor (shaft - rotors) in the pump body bushing wear due to the central of the two rotors. In the spectrum analyze, an occurrence of the maximum amplitude (9.23 mm / s) at the fundamental frequency of the machine (1xrpm = 2880rot/min) Figure 5.This fundamental frequency generates misalignment defects and / or imbalance.

For an accurate analysis of the defects of a machine, it is very important to know the time evolution of a vibration values (highlighted by trends) and data / information on technological parameters, any system crash (electric shock / shock technology, etc.) . These aggregates can lead to more accurate diagnosis of the defect. Vibration values were increasing, which means that the defect had increased over time (wear in development). When removing the pump was found that the central hub of the two rotors were worn, the rotor being misaligned in the pump body.

After replacement and alignment machine was rebooted.Vibration values measured after one month showing a decrease from 11.8 to2.0 mm / s, figure 6.

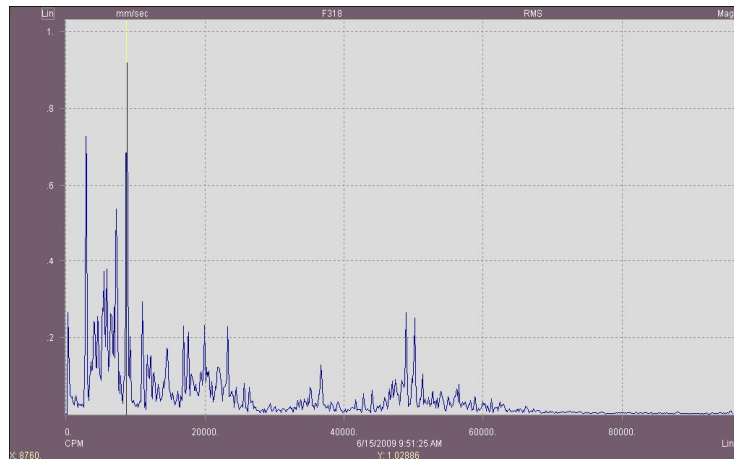
Figure 7. Spectral analysis after fault rectification

Spectral analysis performed, figure 7, has not revealed the existence of the maximum amplitude at the fundamental frequency (1xrpm), which denotes that the defect was correctly diagnosed and removed.

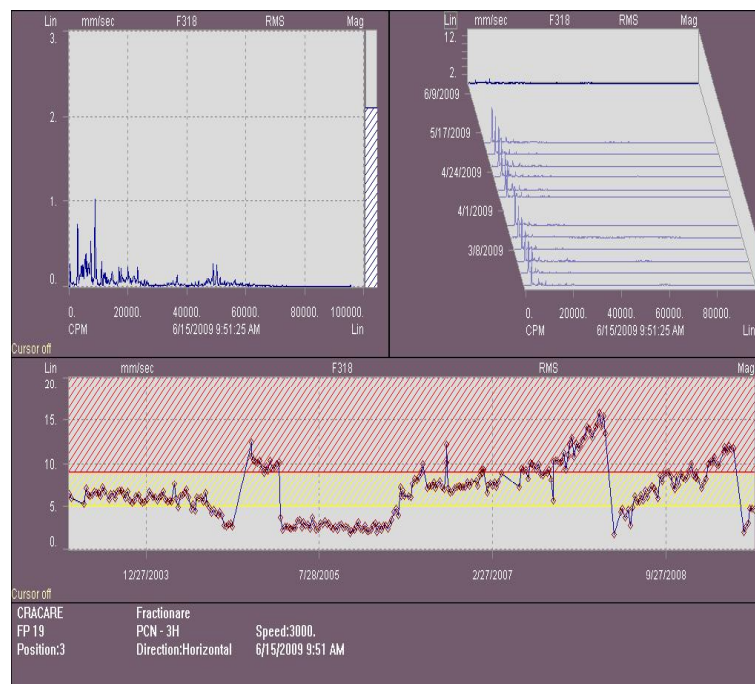
Figure 8. Evolution of vibrations before / after repair

In figure 8 represents the evolution of vibration both before surgery and after surgery. Note the disappearance of the last fundamental amplitude spectrum (top right) and the evolution of "down" the overall vibration after repair value (bottom right).

The yellow color indicates the alarm limit and limit red danger (machine entered after repair limit danger and returned to normal operation).

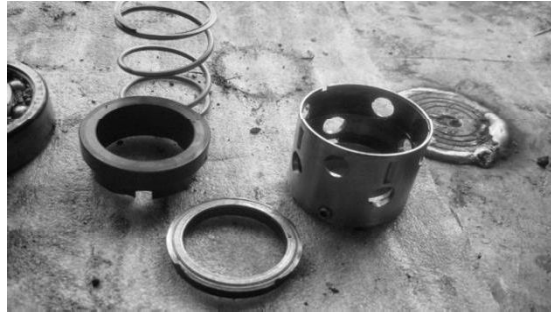
Figure 9. Seal damage

Bushing wear was the main cause of high vibration machine operation. Low frequency vibrations affect both the bearings for pump and seal, figure 9. Dismantling found both in bearing wear and the seal.

To repair this pump was necessary to replace the central hub, bearings and seal and rotor assembly balancing and alignment.
