SCIENTIFIC BULLETIN

A study upon medium displacement Diesel Engine failure

I. Agape*, L. Gaiginschi, S. Talif

Abstract. The study aims to determine the failure cause of an internal combustion engine, in a particular case for a medium displacement diesel engine. The general issue of internal combustion engines failure is very complex and comprehensive. The assumed analysis for achieving this objective is complex and involves a multidisciplinary and gradually approach of the problem, as well as the development of an appropriate methodology to ensure the accuracy of the outcome. In principle, the cause of the engine breakdown is related to its mobile equipment. Based on this assumption, the authors identified all the affected moving parts organs and defined the damage they recorded. Neither fixed collaterally affected parts have been neglected, due to the organic interaction between the mobile equipment and the fixed parts of the engine. The present paper is a real "good practice support" in approaching the causes of fatal destruction of engines, the theoretical considerations being accompanied by a case study.

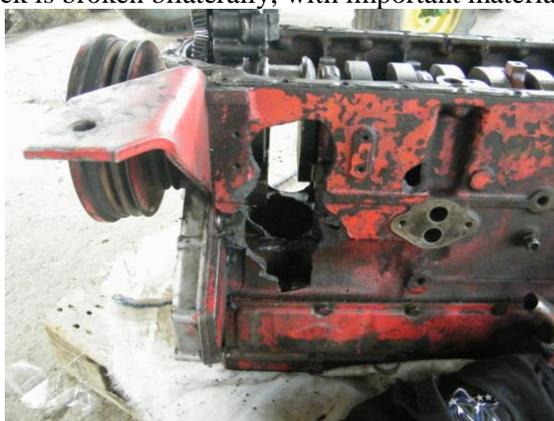
Engine damages are concentrated in the area of the first cylinder, opposite to the clutch position. In this area, the motor block is broken bilaterally, with important material releases (Figure 1).

Figure 1. The engine block. Bilateral breakup

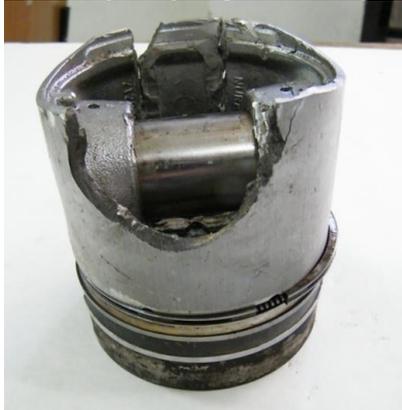
The piston of this cylinder shows breakups with material releases, bilaterally in the plane of the connecting rod oscillation, in the lower half of its skirt. The segments, the piston pin and the shoulder of the piston are integral without significant traces of impact (Figure 2).

The positioning of the damages on the engine block and the piston, corresponding to the oscillation plane of the first cylinder connecting rod, clearly demonstrates that the two components were destroyed by impact with a part of the connecting rod.

Figure 2. First cylinder piston – breakup with releases from the piston skirt

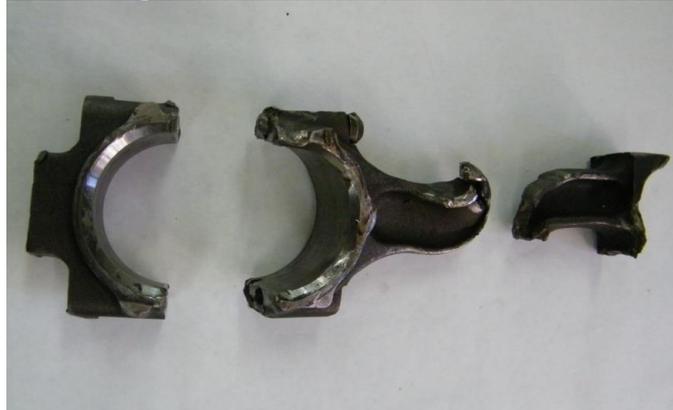
Figure 3. The connecting rod body, broke in two parts

For this reason, the authors' investigations focused on the connecting rod, which broke into several pieces. The rod cap has detached from the body due to rupture of the bolts (Figure 3). The investigations focused on both the overall connecting rod and its weak points (bolts, crankshaft bearing journals) and the connecting section of the rod's small end eye with the body, and took into account the particular functional constructive solutions of this connecting rod.

The rod body is broken by tearing into two parts, the rupture being produced approximately halfway of the beam. The lower part (towards the rod cap) is strongly bent in the rupture area, in the plane of the rod oscillation, demonstrating that it has undergone a bending effort in this plane beyond the permissible limit.

Most likely, this rupture was caused by the impact of very rigid parts of the engine (such as the cylinder and the engine block) in the joint motion of the rod with the connecting rod journal. The upper part of the body (from the small end) is strongly deformed, the rupture being produced by a mechanism similar to the lower part.

The energy required to destroy these organs was ensured by the operation of the other engine cylinders. Finally, the rest of the rod broke in 2 pieces after being hit by the cylinder walls of the engine, causing the bolts to break. This failure mechanism will be further proven with rigorous scientific arguments, but also with the counter-argumentation of the other possible causes. The period in which the engines was designed was an enthusiastic one, with extensive development of engines that tested new materials and solutions in engine construction. For this reason, the validity of some solutions has been investigated conceptually.

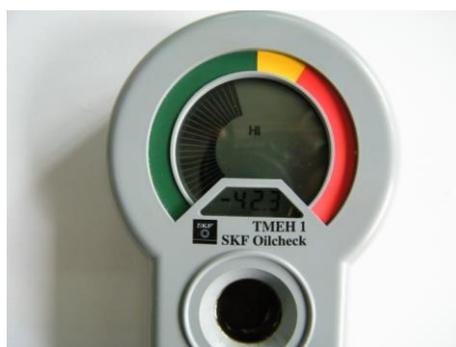
An oil degradation of 41.7 - 42.3 [%] was measured with the TMEH-1 (Figure 4) tester, which summarize up the cumulative effects of altering the oil quality by increasing the water and metal content and by oxidation of constituent molecules and fuel contamination with various other products. For the calibration of the tester, the oil from the engine lubrication was used, namely URSA TD10W40, ACEA E7, A3 / B4, AP CI-4, with a mineral base and a high quality additive.

Figure 4. Sample for lubricant contamination determination

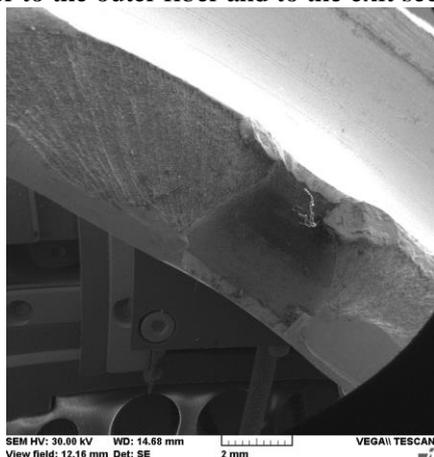
Figure 5. The rupture section of the connecting rod small end

Descending from the outer to the inner area, there is the fracture section during the operation, in a median position, with a smooth aspect, but with lines / micro edges waiting, with the appearance of "sand dunes" and indicating the progressive but intermittent propagation of the crack. The walls of these "dunes" are larger to the inner fiber of the rod's small end, indicating the direction of evolution. The final break area, placed on the inside of the small end's eye, has a matte and quasi-planed appearance, with rare specks of material, not profound.

Finally, the source that initiated the destruction of the engine was a microfissure placed on the outer fiber of the stick of the bead in its plane of symmetry. The area in question was potentially dangerous due to the important stress concentrator represented by the piston pin lubrication hole. This microfissure propagated over time by running until it penetrated the entire section after a fatigue rupture mechanism.

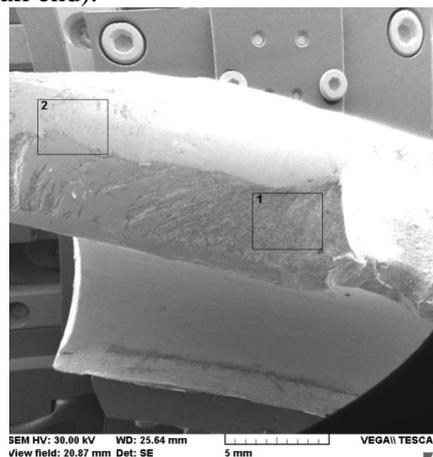
Finally, ultra-modern scanning techniques, using scanning electron microscopy (SEM) and EDAX/EDS spectroscopy, were used. For this, it was used a microscope TESCAN equipped with 4th generation BRUKER QUANTAX shotgun. For the analysis we chose the upper tear-off section of the detachable piece from the rod's small end which contains the bushing hole (Figure 5). The general aspect of this section, which lacks the direct strikes, suggests that this section has initiated the fissure that triggered the mechanism that destroyed the engine. These investigations allow qualitative -morphological and quantitative-compositional analysis at defined points of the section. Element analysis was done based on the specific energy spectra of the chemical elements in the predefined points of the section. Two areas of interest (photo 6) were defined, zone 1 (closer to the inner fiber of the connecting rod's small end and in the vicinity of the lubrication hole) and zone 2 (closer to the outer fiber and to the exit section in the small end).

Figure 6. Positioning of analysis areas in the section

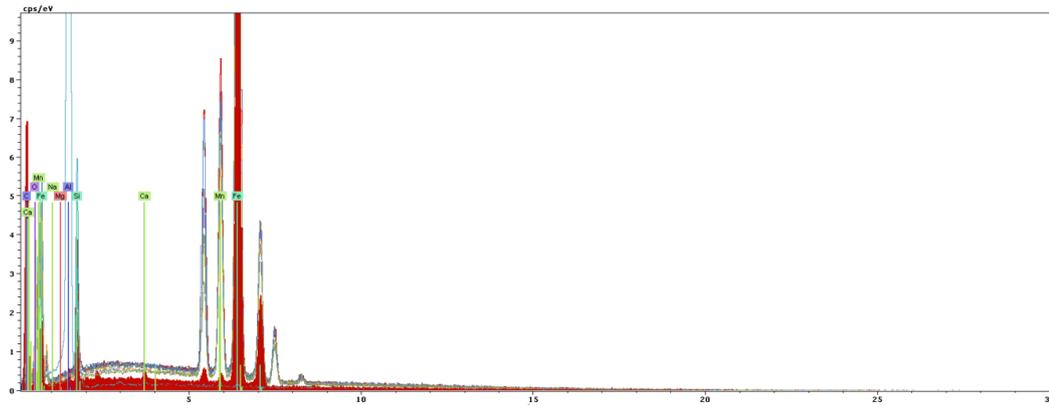
Figure 7 shows the dispersion diagram of the specific energy for the chemical elements identified in zone 2. First of all, we note the morphology of the rupture section through fatigue from the outer fiber to the inner one. The rupture surface is relatively smooth and has distinct areas. To the outer fiber (to zone 2) the fissure primer appeared, favored by the brutal concentration of stresses at the lubrication hole. The initiation could be favored by possible non-metallic inclusions, superficial structural irregularities or even micro fissures caused by heat treatment applied to the connecting rod.

Figure 7. Elementary energy dispersion diagram (ie on chemical elements).

The superior wealth in the elements of the zone 2 compared to 1 indicates the direction of propagation of the initial crack, respectively from the outer fiber to the inner one of the small end's eye.
