Study on improving the sewing process by applying the QRCI method in the automotive industry

Abstract. The aim of this paper is to analyze and resolve the non-conformities identified by the internal quality control for the studied product, "Insert the front door side panel". The paper presents the way to identify the causes of non-conformities in the manufacturing flow, by analyzing the way of carrying out the activities and the reference documents within the workstations where the non-compliant products were manufactured. Because the problem was identified in time, nonconforming parts were not delivered to the customer, thus avoiding a complaint from him. An internal QRCI was opened to solve the problem. If the nonconforming parts were delivered to the customer and the customer filed a complaint with the supplier, a thorough 8D analysis was required.

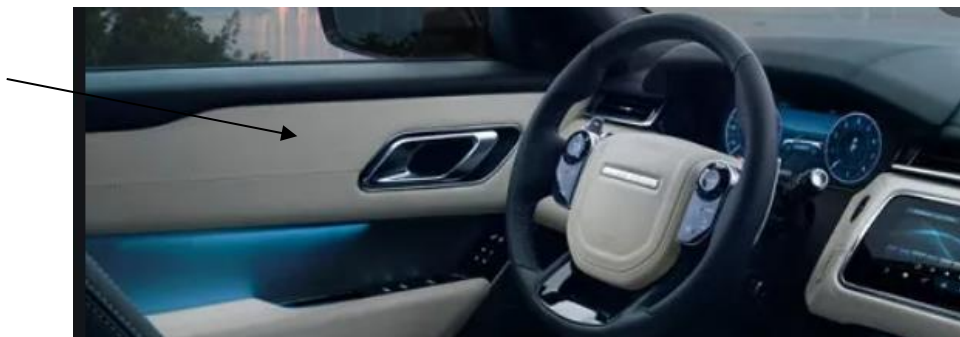
Figure 1. Analyzed product

" Insert the front door side panel " is the subject of the study. It consists of a plastic part, which is ordered from a supplier and four inserts made of natural leather or PVC, depending on the customer's preferences, inserts made on the manufacturing flow.

In appearance it has several functional seams and a decorative seam positioned in the middle.

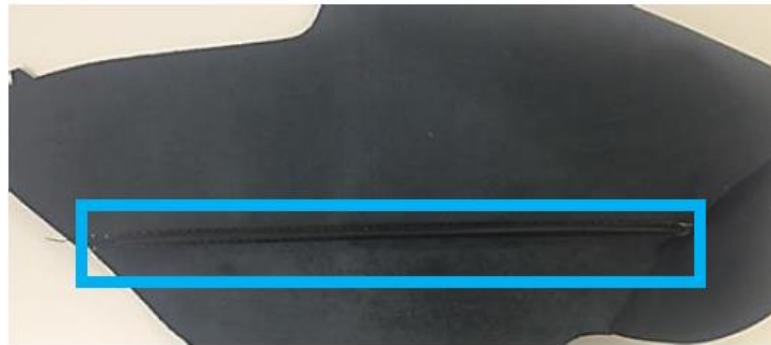
Figure 2. Component 2 with sealing rubber

The 2 components were compared and it was found that Component 2 has a piece of reinforcement under the decorative seam called PREPO (reinforcing rubber insert), which has the role of keeping the decorative seam straight, figure 2.

It was also stated that the factory standard stated that: "All parts of all existing designs with a decorative seam must have a rubber reinforcement to keep the decorative seam straight."

1. It was decided to purchase new sewing machines with special devices for inserting and sewing the rubber band.
2. A safety stock has been made to replace the old sewing machines with the new ones, equipped with the special device.
3. Replacing old sewing machines with new ones.
4. Perform an adhesion test to see if the rubber band sticks to the sponge to avoid delamination.
5. The PFMA is updated (Analysis of failure modes and their effects). The use of rubber bands for such parts is mandatory in the action plan and also in the quality standard.
